**INSPECTION PROPERTY ADDRESS:**                   **XXXX Street**  
Houston, Texas

**INSPECTION PERFORMED FOR:**                   Mr. Buyer

**INSPECTION DATE:** 12/16/10

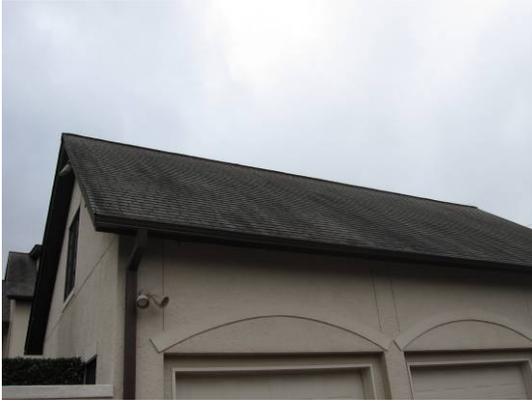
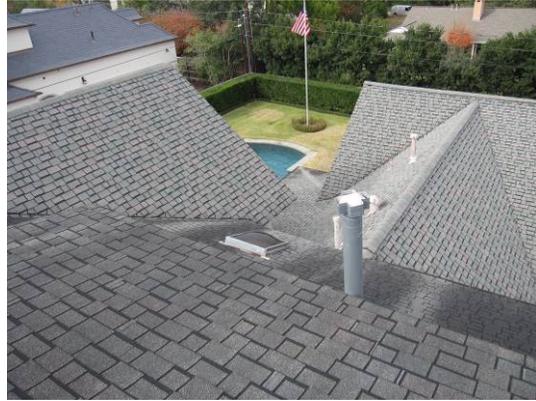
The roof covering is composition shingles. The shingles had experienced minor to moderate weathering. There were discolorations on the shingles that were considered normal for a roof of this age. It is recommended that the roof be monitored during rains for any signs of leakage.

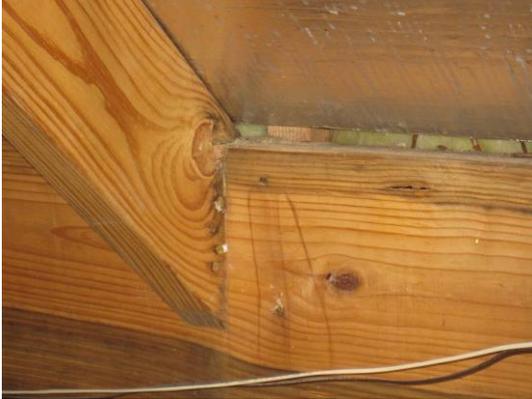
There were various stains at the attic framing. These were dry at the time of the inspection. This appears to be a result of original construction.

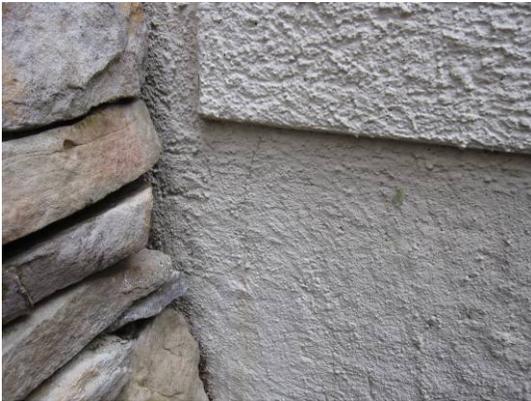
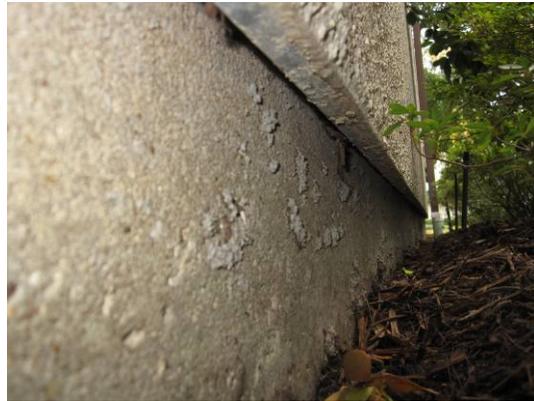
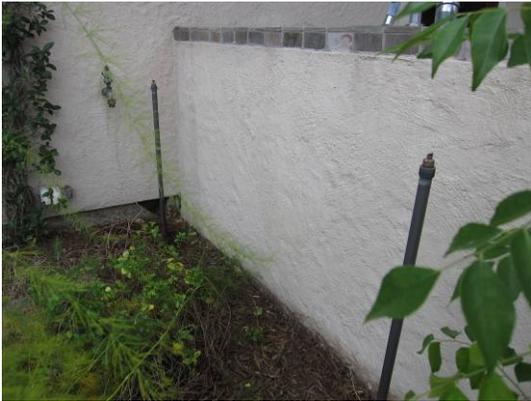
We make no representation to whether the stucco was installed in accordance with any particular standards. There were a few typical small hairline cracks at the stucco. No weep screed flashings were installed at the lower stucco and stone details. Modern stucco and stone lower details use a weep screed flashing to help control moisture. There was soil in contact with the lower stucco at the outdoor kitchen. Slab exposure is recommended to help prevent moisture and wood destroying insects. Be advised that this was a limited visual inspection of the stucco and stone details. Should you desire additional evaluations, interior wall probe testing and/or infrared camera survey could be performed.

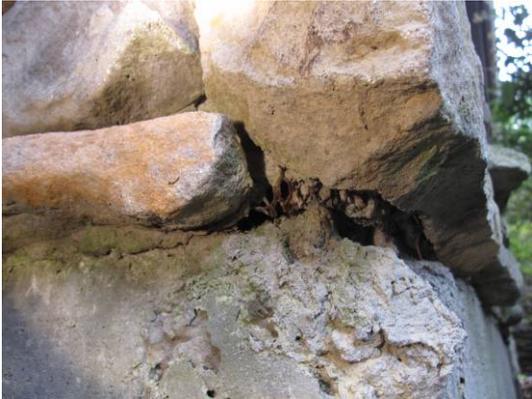
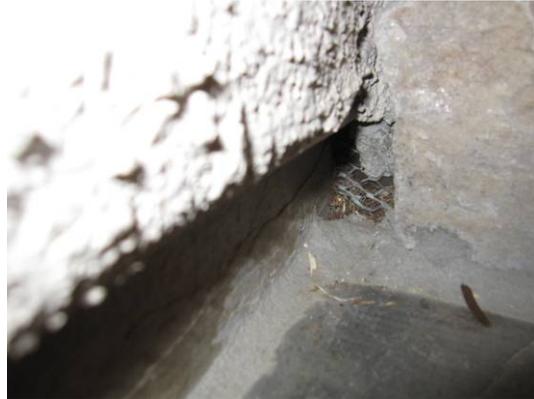
We make no representation to whether the cultured stone veneer was installed in accordance with any particular standards. However, there are concerns about a few of the stone details. There were a few small areas of exposed metal lath. These areas should be properly covered to prevent deterioration and water penetration.

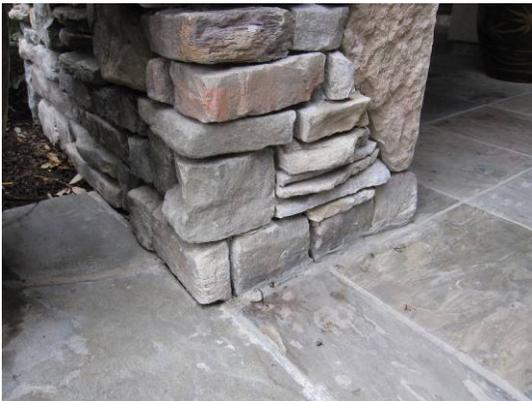
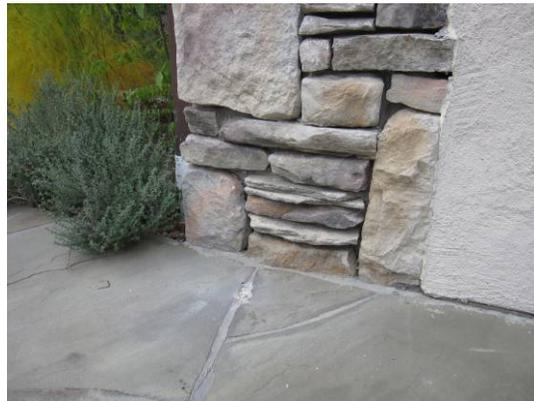
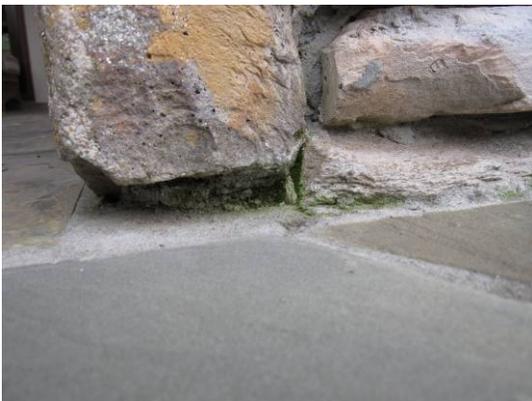
The lower details of the stone columns at the front and rear exterior are in contact with horizontal surfaces. This is a concern for moisture.

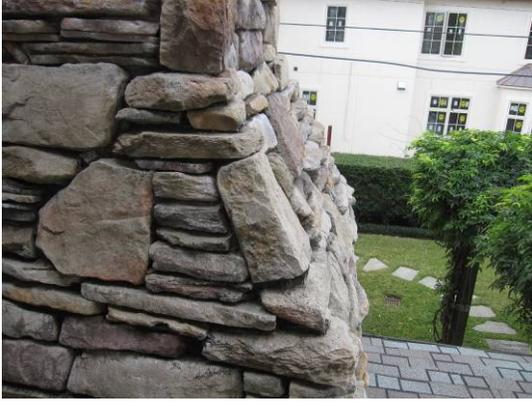
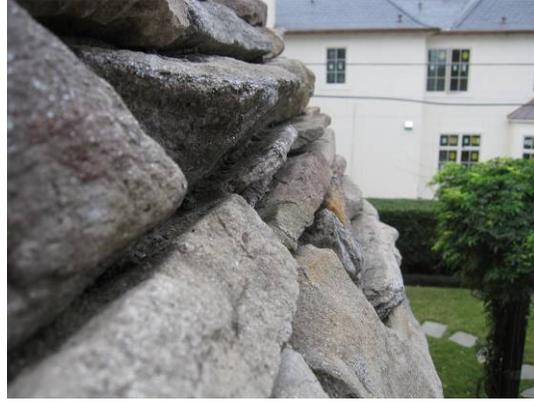
The stones were installed so that moisture can collect at a few areas. This was most evident at the angled stones at the chimney shoulders. Water should readily drain away and not be allowed to collect. The house should be monitored for any water penetration.

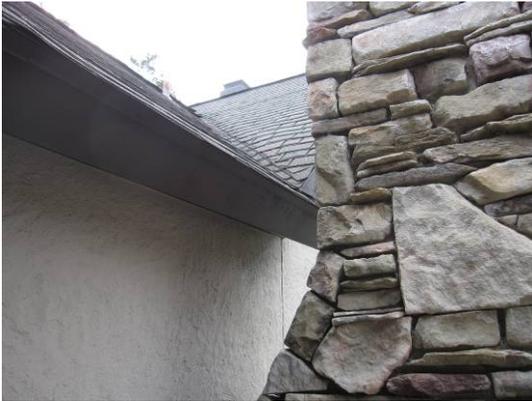
The roof sheds water onto the chimney at the left rear. This is a concern for moisture. This condition should be monitored for any water penetration.

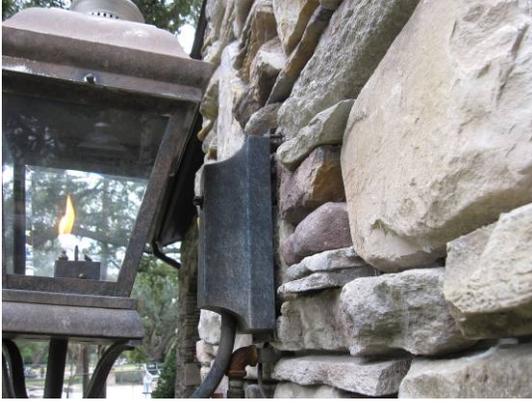
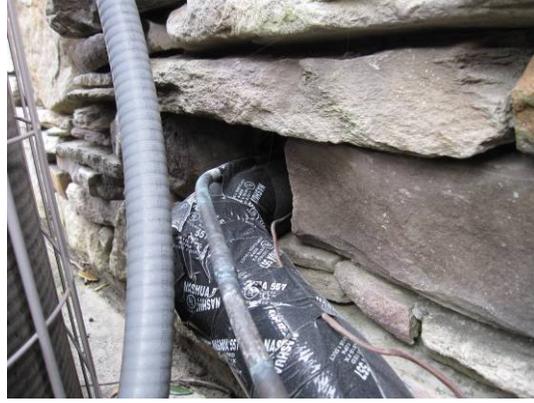
There were some penetrations through exterior walls that were not adequately sealed to prevent water penetration. All exterior wall penetrations should be properly sealed.

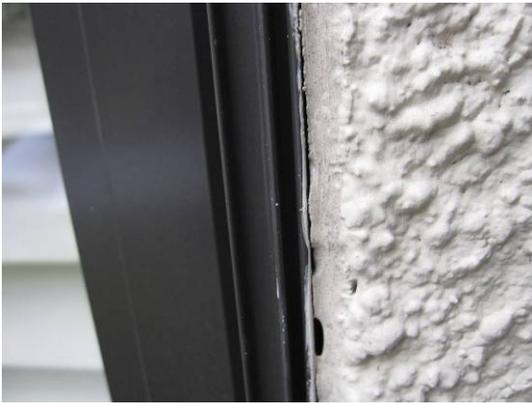
There was limited caulking at some windows. Thorough caulking is recommended.

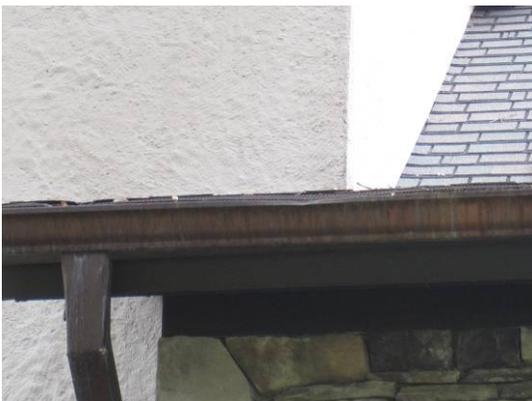
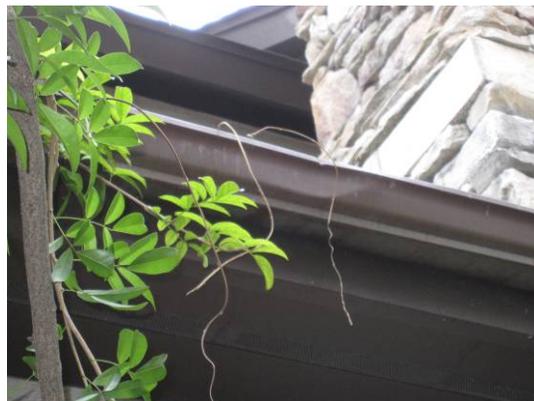
For your information, there were small dents at gutters at the front left and left rear.

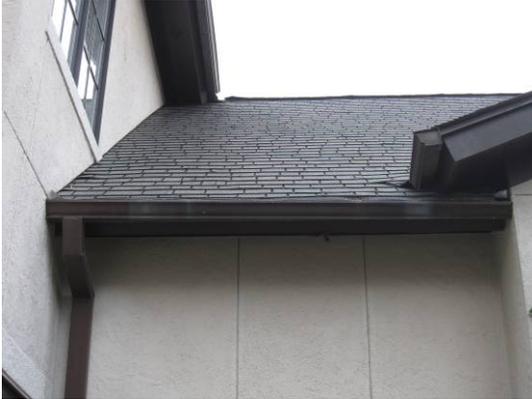
A gutter at the right side was sagging. There were signs of overflow at this gutter. Adjustment is needed.

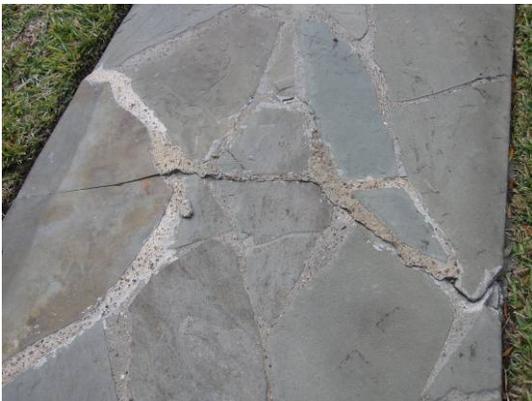
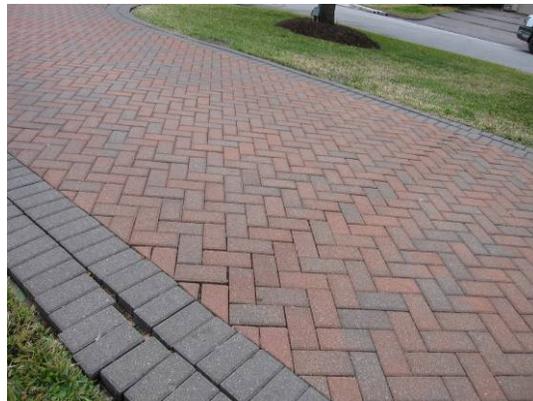
For your information, there were a few cracks at the front sidewalk. There was some displacement at driveway pavers.

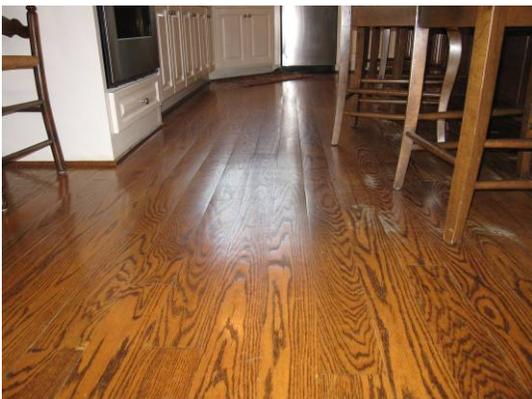
There was minor wood floor warpage at the kitchen area. Warpage is generally a result of moisture. It is our understanding that there was a previous leak at the icemaker. This condition should be monitored.

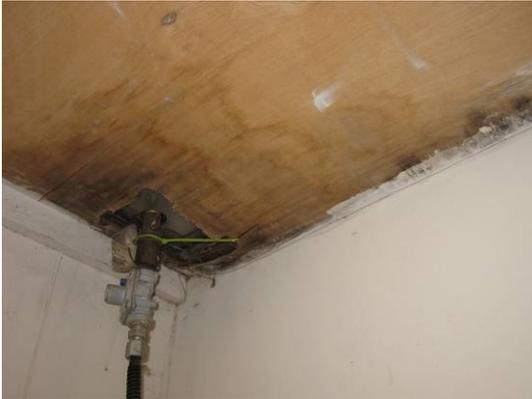
There were signs of water penetration that were observed under the outdoor kitchen grill. Repair is needed.

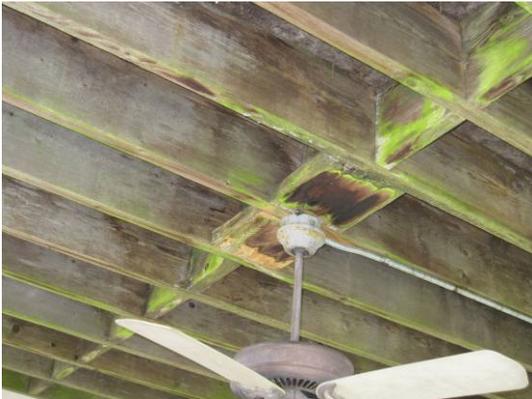
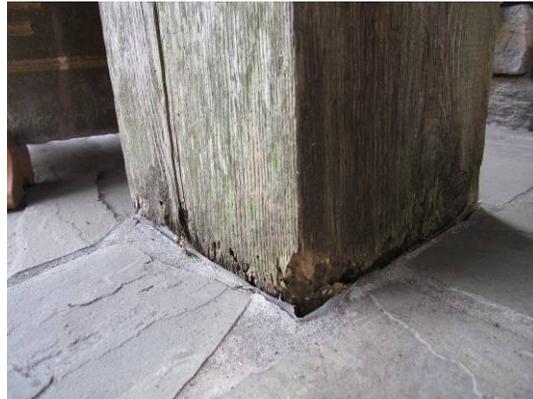
There was some wood deterioration at the pergola in the backyard.

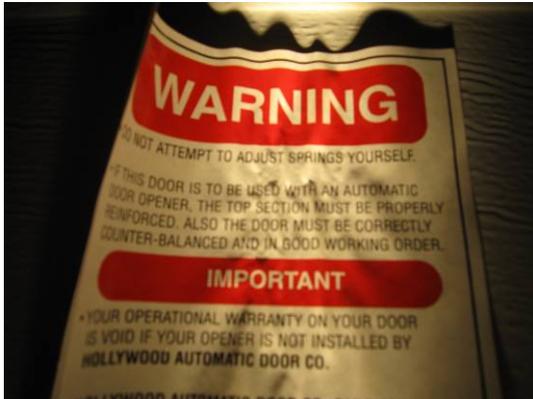
The garage overhead door top panels were not reinforced. These should be reinforced for the garage door electric operators.

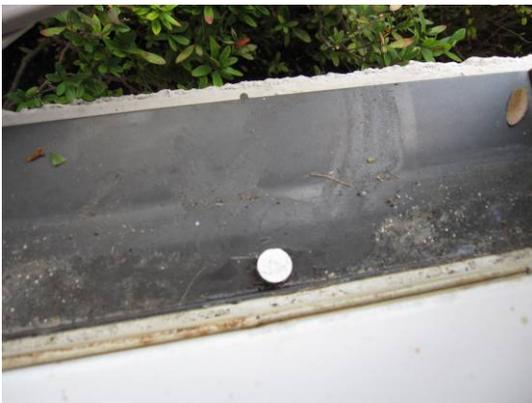
There was limited caulking at security sensors at the windows. Additional caulking would generally be expected to help prevent water penetration.

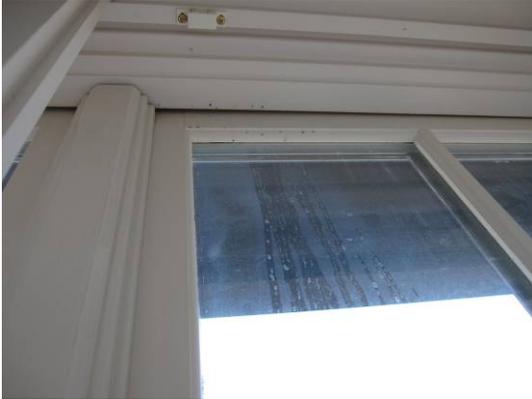
There were stains at a window at the second floor right bedroom rear window. This water penetration condition is in need of being repaired.

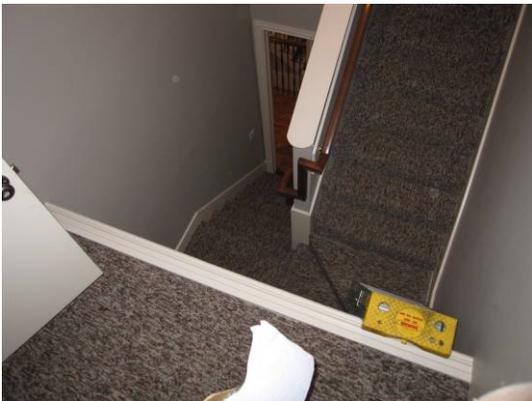
There was no balcony rail at the small balcony at the access to the mechanical equipment at the third floor stair area. There should be a balcony rail.

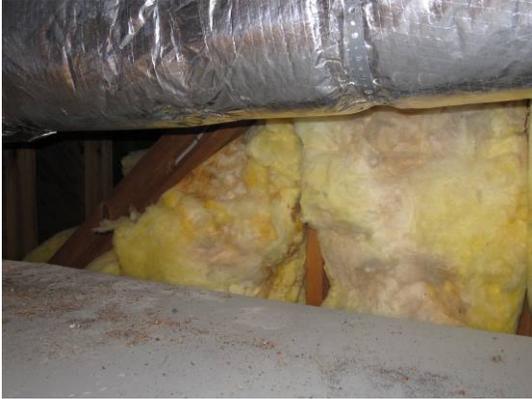
There was some discoloration at wall insulation at the far left attic. The reason for this was not determined. This area should be monitored for any water penetration.

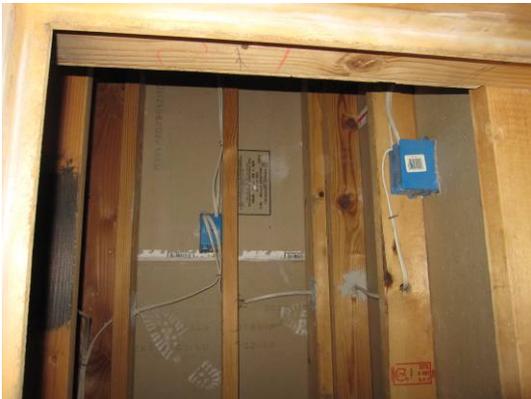
The air conditioner return airs were not sealed. There was exposed electrical wiring in the return airs. It is recommended that these be completely sealed.

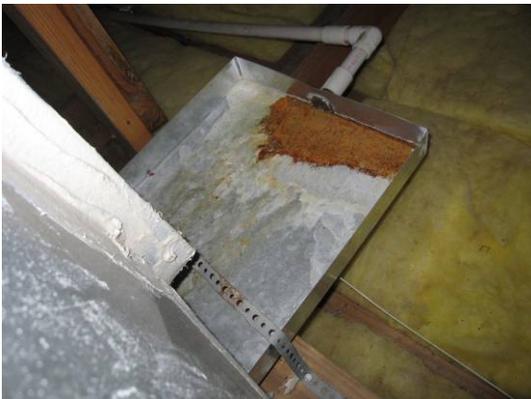
There were signs of some previous air conditioner condensate leakage. This should be monitored during warmer weather.

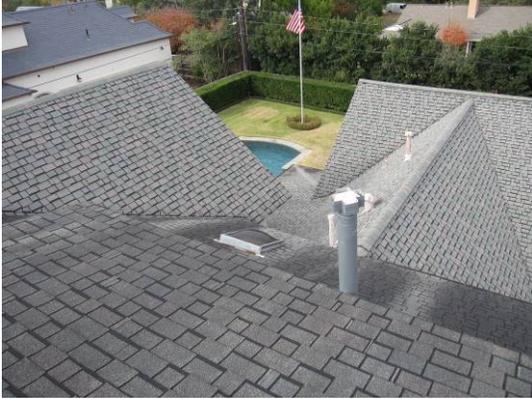
The rear furnace vent was improperly in contact with shingles at the perimeter of the roof. It appeared that this had been recently modified. There should be a minimum 1" clearance to combustibles.

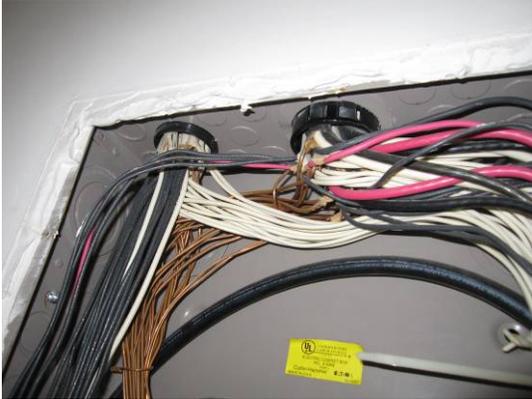
There were bundled wires at the penetrations through the electric panels. This is not allowed by current standards.

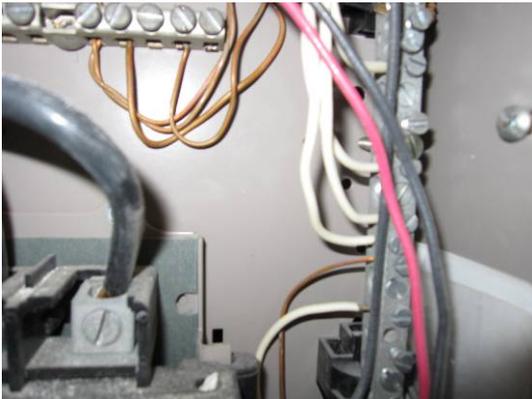
One of the ground wires was improperly connected at the neutral bar at the subpanel. This should be connected at the ground bar.

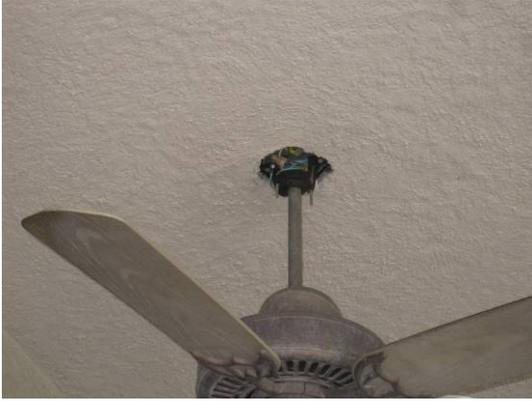
There was a loose escutcheon at the back porch ceiling fan. Repair is needed.

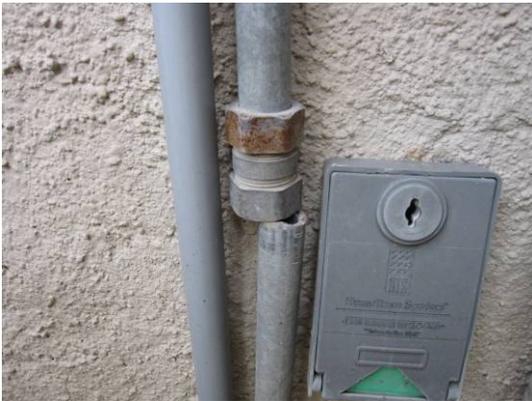
There was disconnected conduit at the left exterior near the front left corner. Repair is needed.

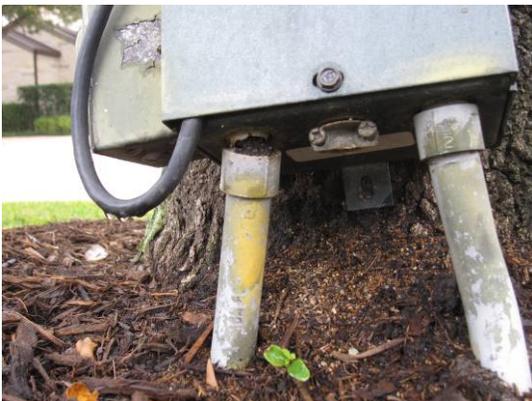
There was a broken conduit connection at an east tree. Repair is needed.

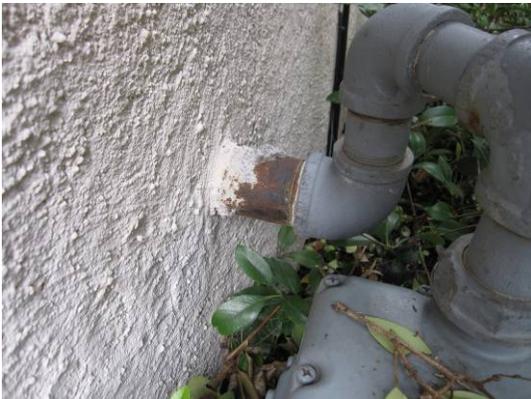
Corrosion protection is needed for the gas piping adjacent to the meter.

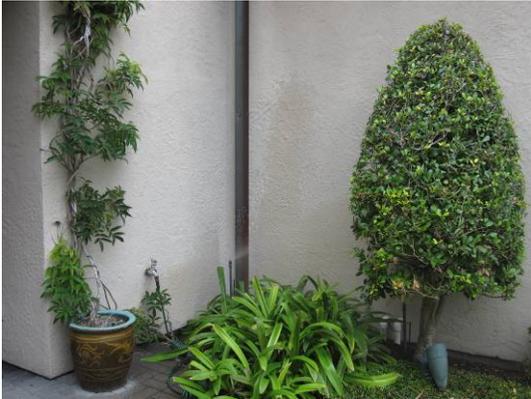
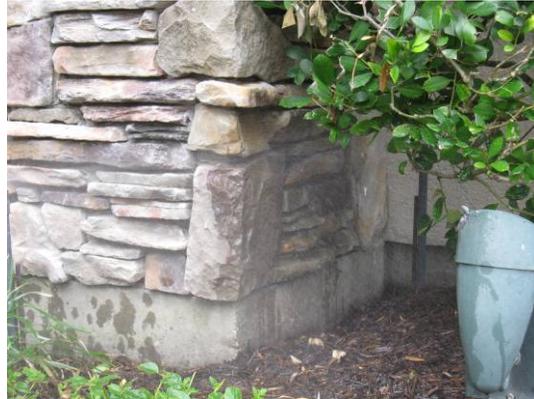
The lawn sprinkler system was operated manually from the control panel during the inspection. Various heads improperly sprayed on the house. These are in need of being adjusted so that they do not spray on the house. Zone nine was bypassed when the controller was manually operated. Appropriate repairs are needed.
