**INSPECTION PROPERTY ADDRESS:** XXX Lane  
The Woodlands, Texas

**INSPECTION PERFORMED FOR:** Mr. Woodlands Buyer

**INSPECTION DATE:** XX/XX/XXXX

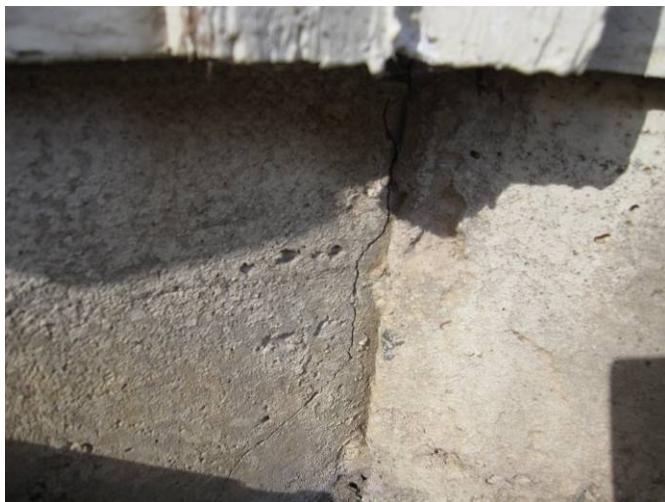
Observations revealed signs of minor to moderate foundation movement. A few typical hairline cracks were observed at the perimeter of the foundation. There was a small brick veneer crack over the right exterior door at the porte cochere. It is recommended that you consult with the seller to determine whether there have been any previous wall repairs. There was some floor unlevelness. This was most evident at the left side of the house at the master bathroom area. There was floor unlevelness of approximately 3/8" in 4' at the master toilet area. Some of the floor unlevelness was attributed to original construction and some was attributed to minor to moderate foundation movement. There were signs of minor door misalignment.

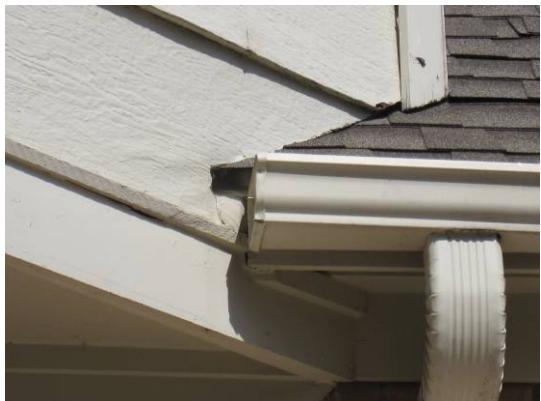
There was deteriorated siding and no kick-out flashing at the right rear. Repair is needed.

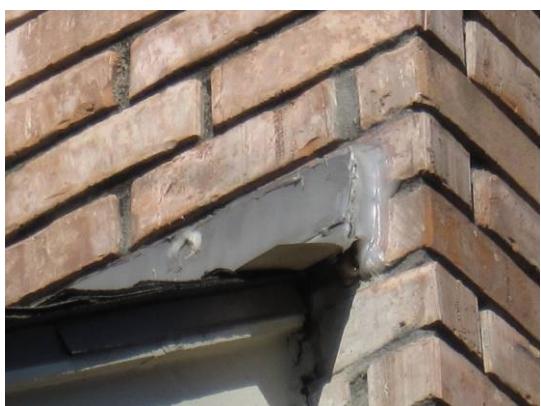
Much caulking had been applied at the right rear chimney flashing. There was a difference in ceiling texture. Please consult with the seller about any leakage. This amount of caulking would generally not be needed if there is adequate flashing. This should be monitored for any leakage.

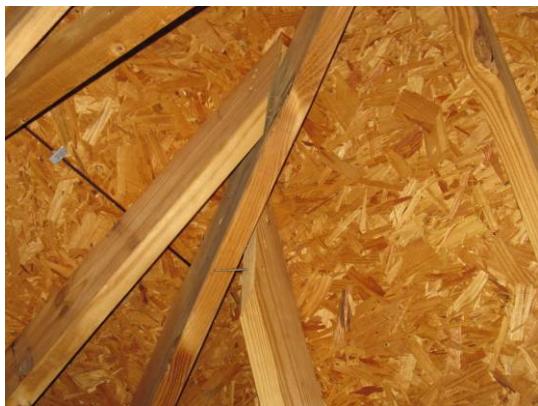
There were some poor framing joints. Reinforcement could be performed.

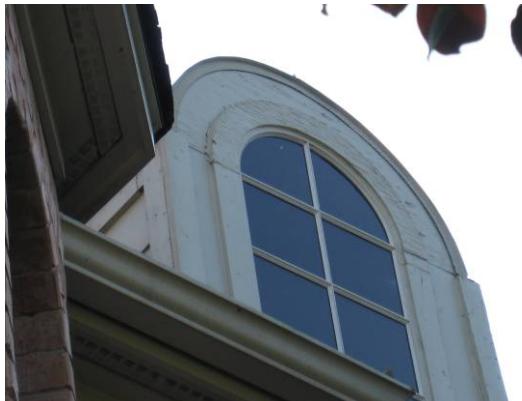
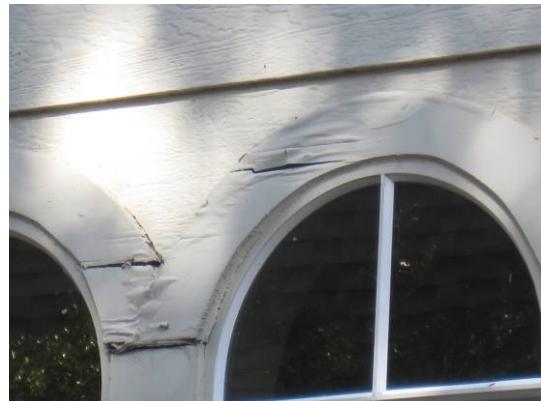
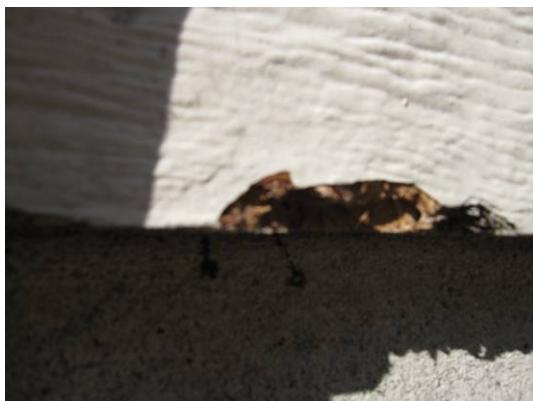
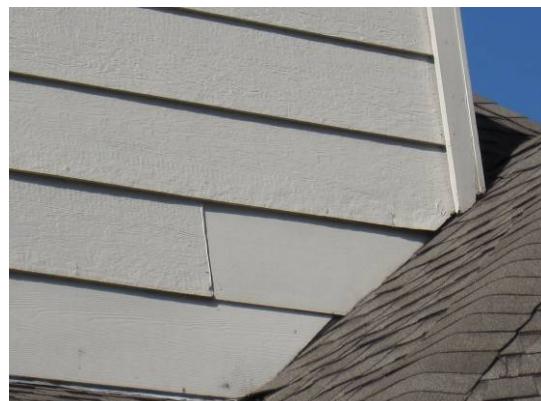
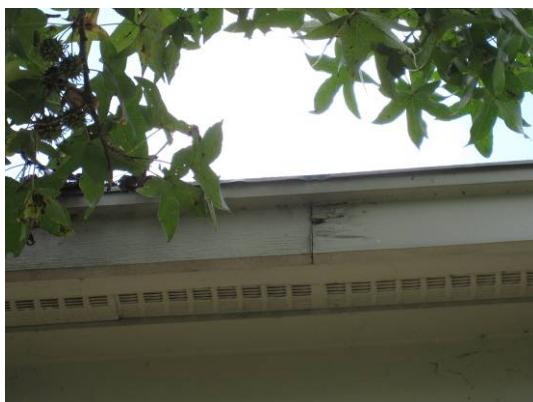
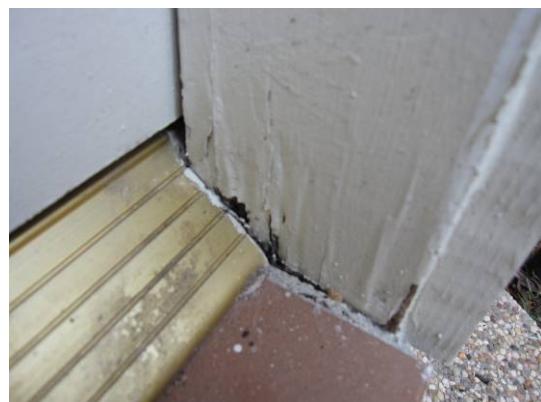
Some areas of exterior siding and wood trim had been previously replaced. There were still various areas of deteriorated siding and trim that are in need of being replaced. Be advised that this type of original exterior siding has a history of deterioration.

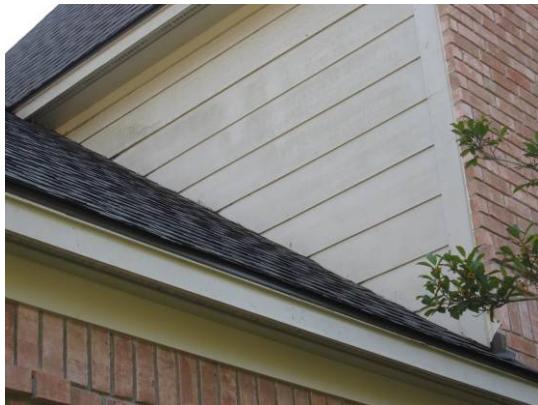
There were some areas of siding that were improperly in contact with shingles. There should be proper clearances, in accordance with manufacturer's installation instructions.

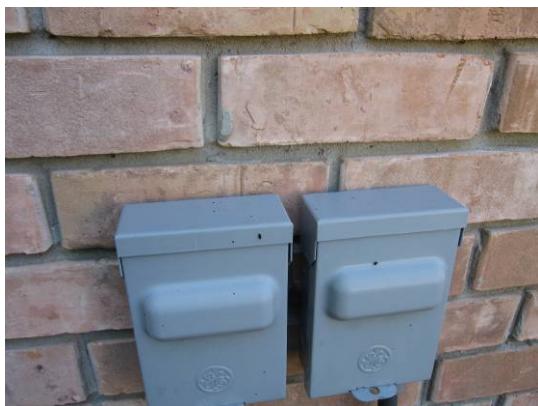
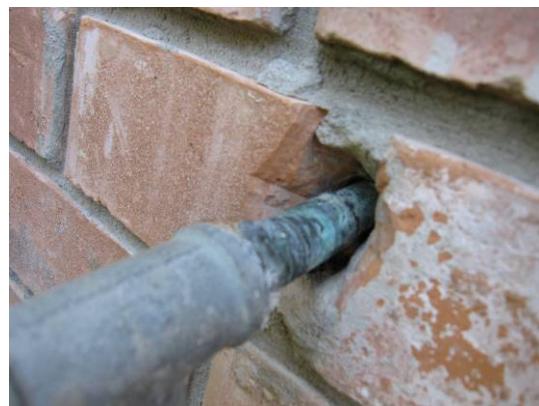
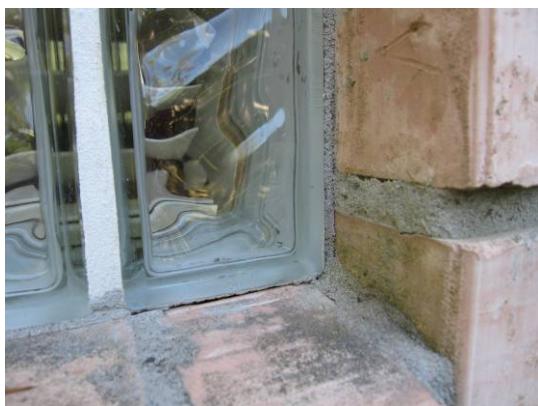
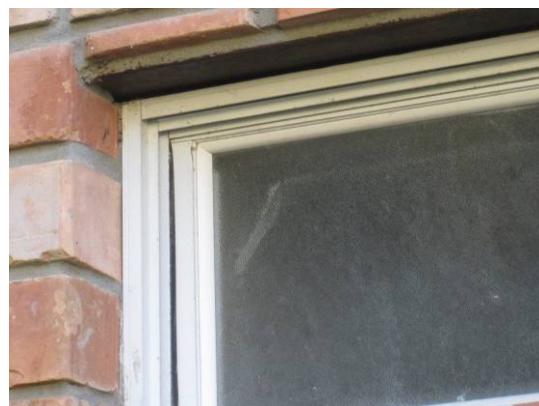
There was inadequate caulking at various exterior details. Proper caulking is needed.

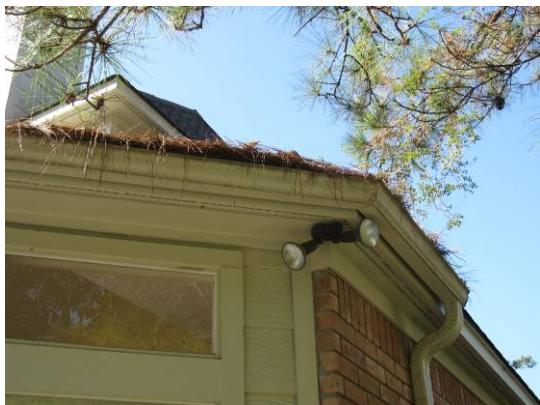
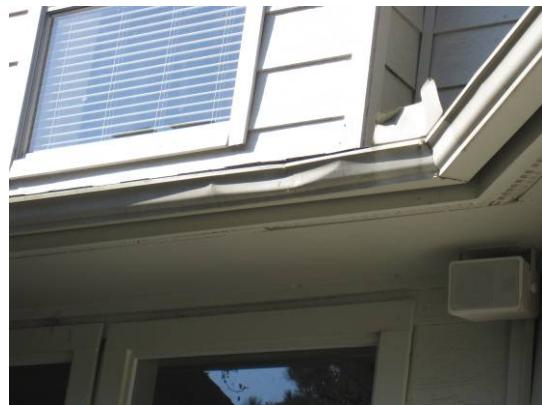
There was debris at gutters. There was a bent gutter at the rear. There were signs of apparent gutter overflow at the rear. Repairs are needed.

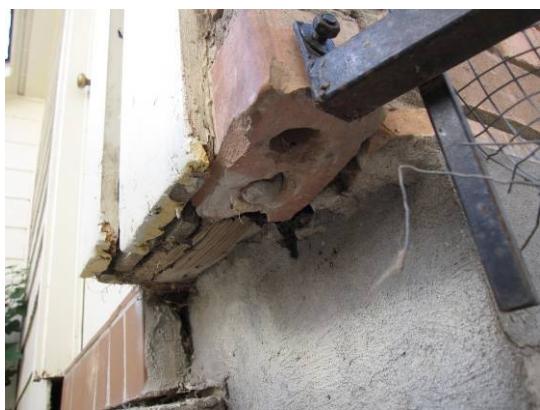
The wall was overhanging the perimeter of the foundation at the front left corner of the garage. Proper support is needed.

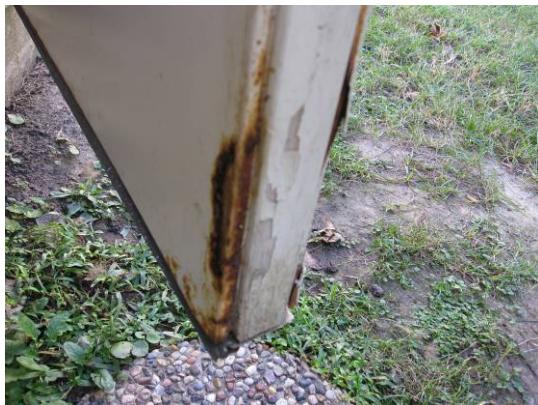
There was deterioration at the garage bathroom exterior door.

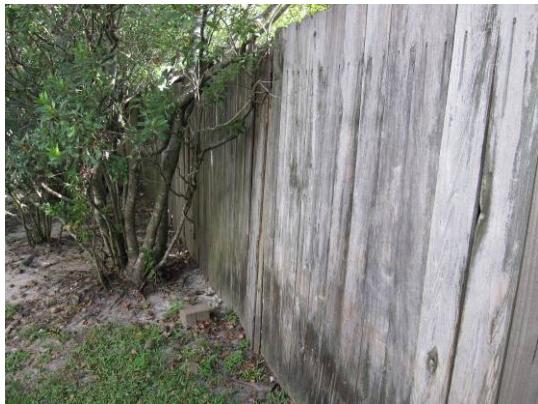
There was some deterioration at the yard fences.

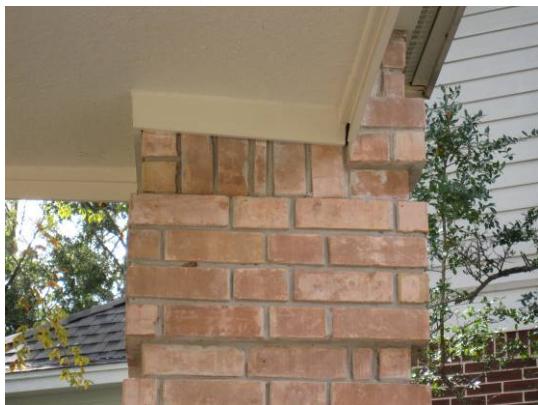
There were some unlevel components at the carport. This may be a result of original construction.

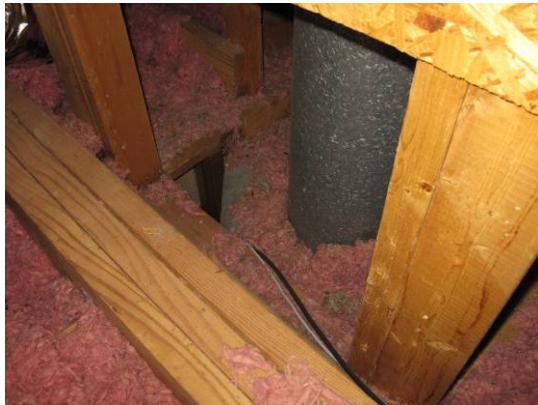
There was an inadequate fire block at a chimney in the attic. Repair is needed.

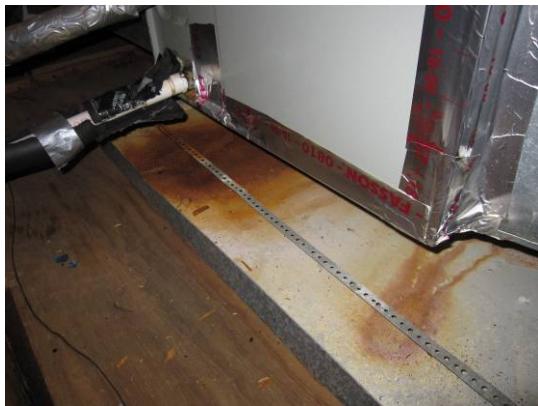
There was rust at the two air conditioner drain pans. No leaks occurred in these areas at the time of the inspection. This should be monitored during warmer weather.

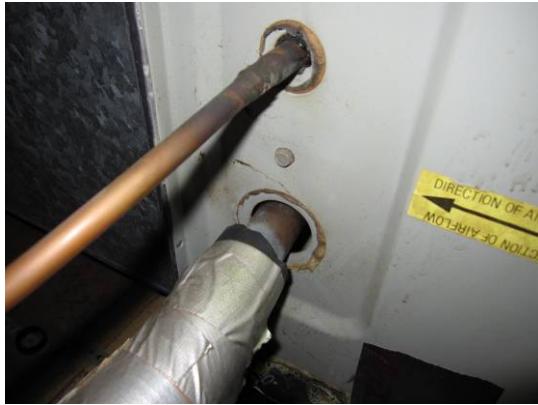
There were air leaks at the refrigerant line connections to the evaporators. These are in need of being sealed.

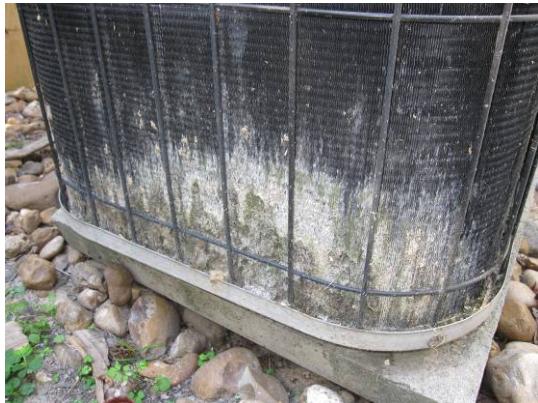
The garage air conditioner was unlevel and deteriorated.

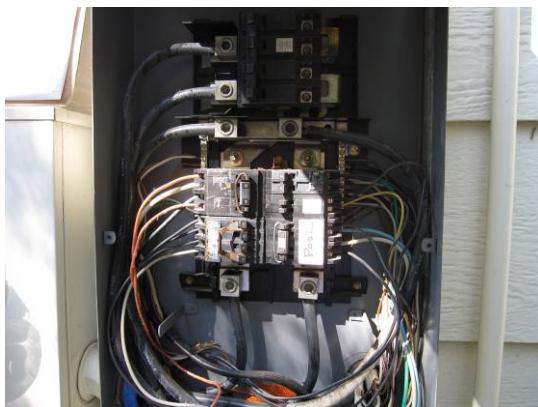
The electric panel at the rear of the garage had the following deficiencies: no main breaker for circuits at this panel, some circuits not labeled, improperly double lugged neutral wire connections, 40 amp breaker improperly protecting #10 AWG wire and no panel bond connection observed. Repairs are needed.

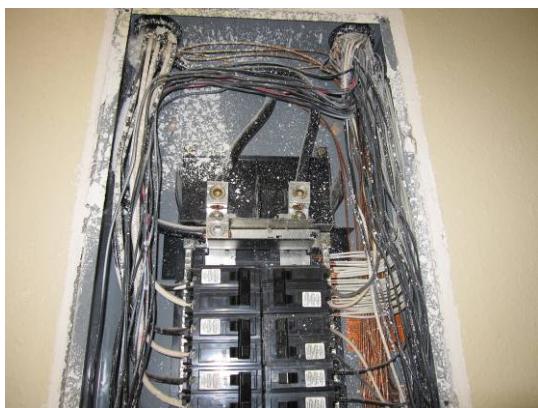
The following deficiencies were observed at the utility room subpanel: improperly double lugged neutral wire connections, missing common tie on multi-wire circuit breakers (red and black wire), and bundled wires at penetration through panel. Repairs are needed.

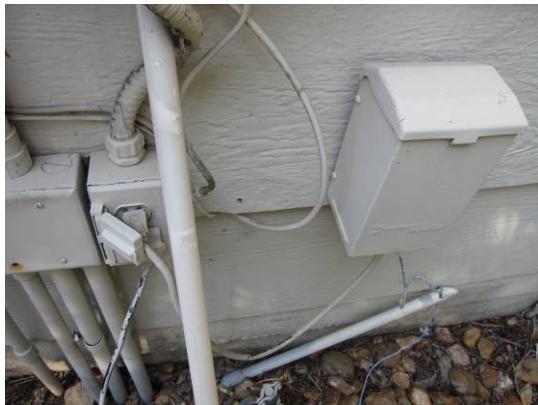
Repair is needed at the yard light controller plug-in connection at the rear of the garage.

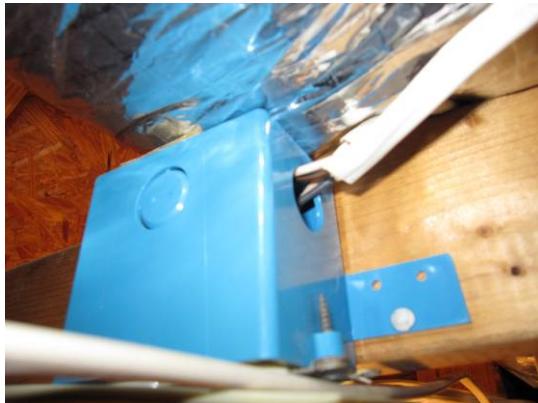
There were various items at the garage that do not meet current building code standards. Appropriate repairs are needed.

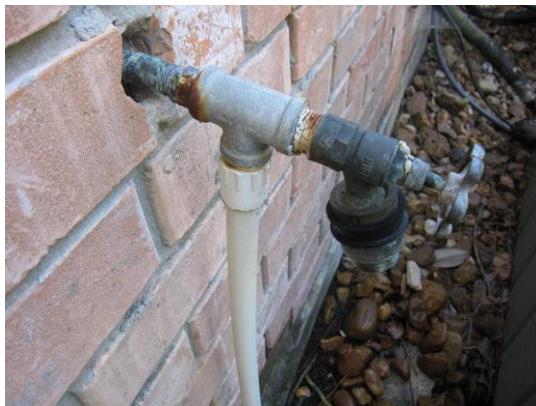
Most of the piping is copper material. There were a few areas of galvanized fittings improperly connected to copper piping. Repair is needed, due to the potential for corrosion at these dissimilar metals. This was observed at the left exterior and at the left attic water heater.

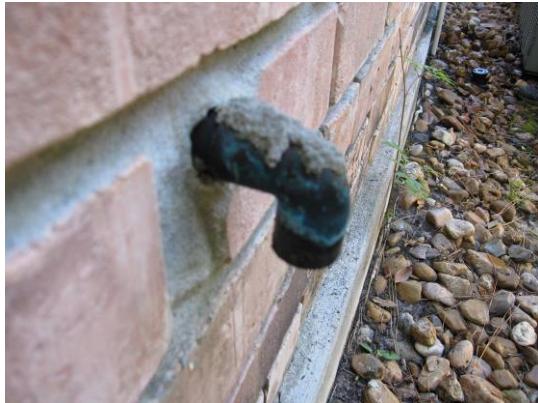
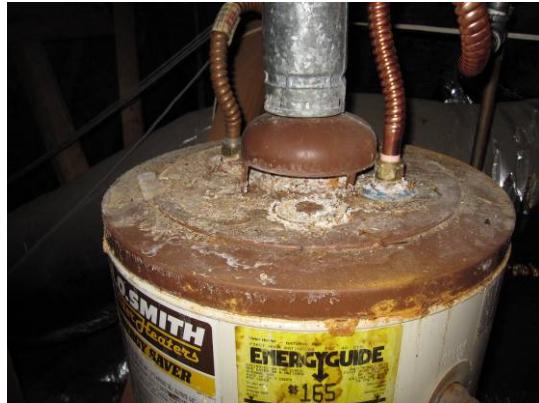
There was leakage at an elbow at the left exterior. This was apparently for the water heater. The water heaters were deteriorated. It is recommended that you consider replacing the water heaters. There was only one drain to the exterior for each water heater. Water heaters should have independent drains to the exterior for the safety relief valves and drain pans.

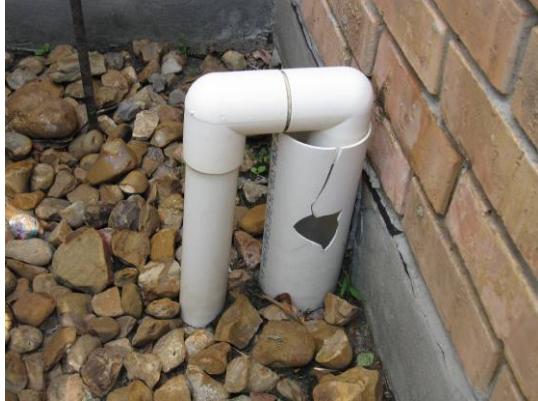
There was a broken pipe at the front right exterior. Repair is needed.

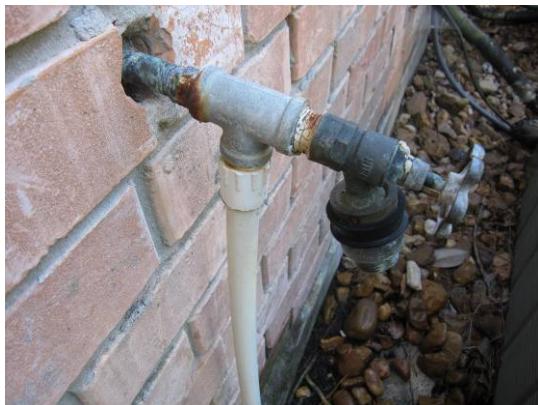
There was a dripping faucet at the left exterior. There was moisture at the exterior of this wall and perimeter of the foundation. The moisture may be a result of the dripping faucet or may be a result of some internal leakage. Appropriate repair is needed.

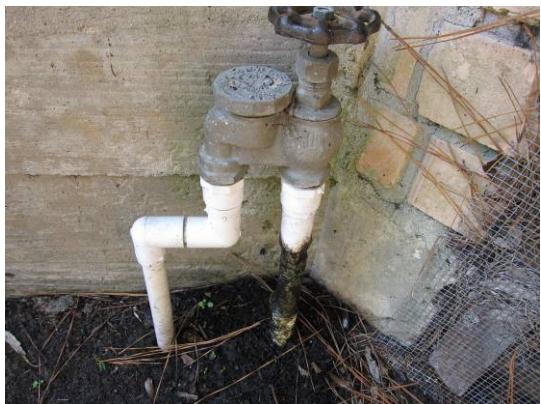
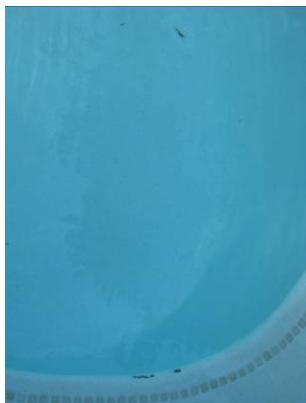
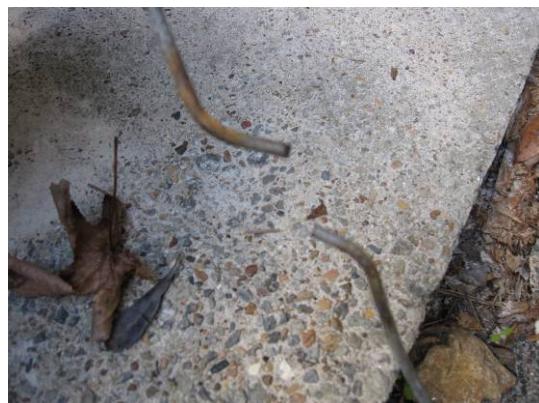
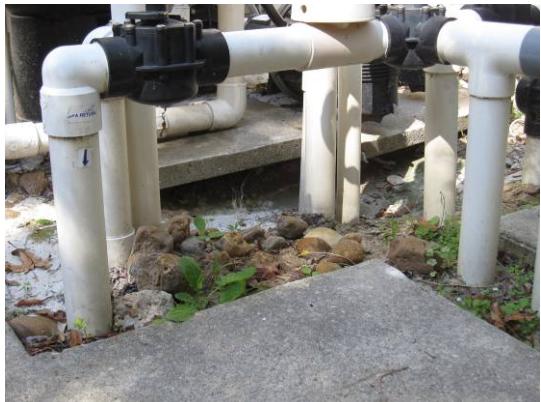
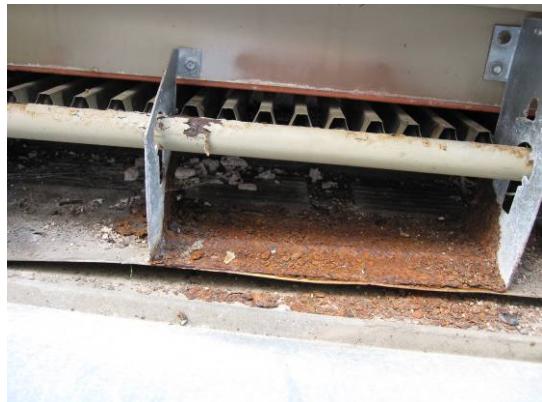
The swimming pool and spa, as well as the associated equipment were visually inspected. Be advised that we have performed no leak-testing. The filter was not backwashed or drained as a part of this limited visual inspection. There was an inadequate safety barrier around the pool and spa. A proper safety barrier would include self-closing/self-latching gates and doors, etc. The swimming pool appeared to be constructed of gunite and plaster. The plaster was deteriorated. It is recommended that you obtain quotes for replastering. There was leakage at the water supply to the swimming pool at the left rear corner of the house. The equipment consisted of pool sweeper, lights, spa blower, three motors/pumps, three timers, filter, and gas heater. The switch for the lights was not found. Please consult with the seller. The ground fault circuit interrupter for the pool lights did not trip with a test device. This important safety device is in need of being repaired. There was no gas shut-off valve adjacent to the gas heater. There were disconnected electric bond wires at the equipment. There was disconnected conduit at the wiring to one of the pump motors. The on/off pins were missing at the fountain pump timer. The gas heater was rusted. There was some soil erosion under the concrete pad for the equipment. Service and appropriate repairs should be performed by qualified contractors.

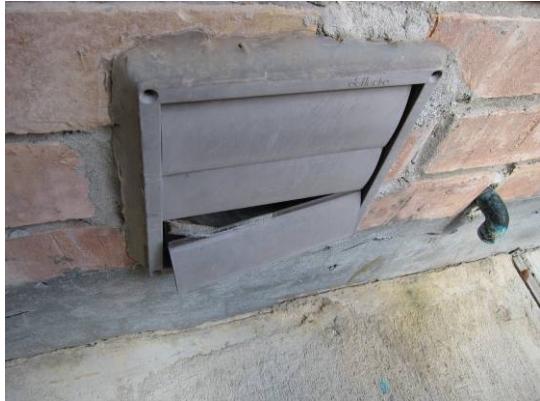
There was damage to the cook top vent at the right exterior. Repair is needed.
