**INSPECTION PROPERTY ADDRESS:** XXXX Court  
Richmond, Texas

**INSPECTIONS ORDERED:**

Foundation Only

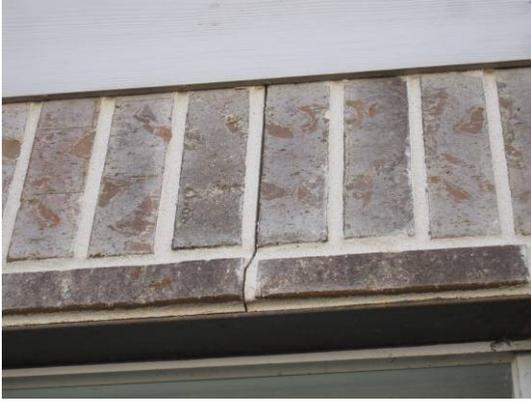
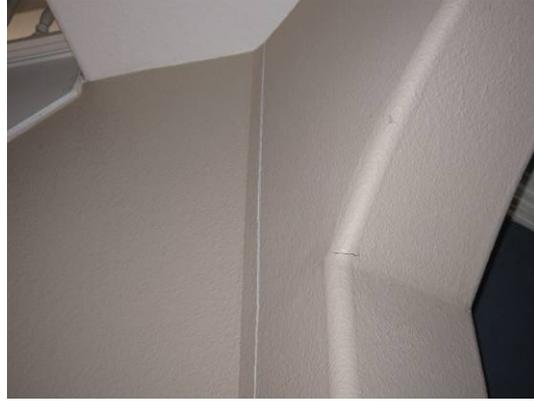
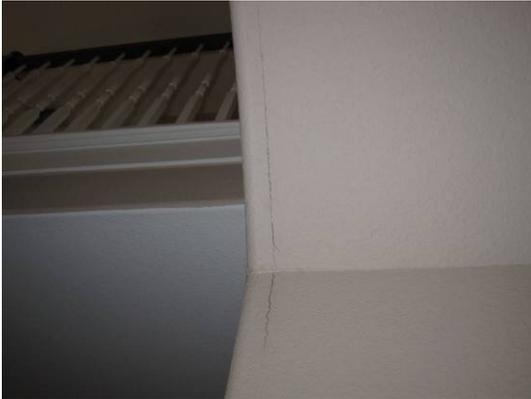
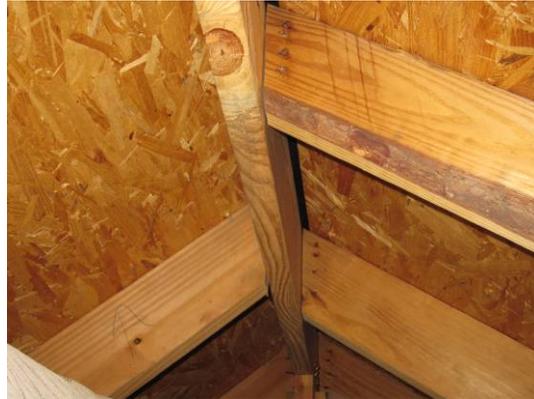
Observations revealed signs of minor to moderate foundation movement. There was a brick veneer crack with approximately  $\frac{1}{8}$ " separation at the left side. The bricklines were straight, as visually observed from the exterior. Front frieze board joints had separated up to  $\frac{3}{8}$ ". There were some brick joints that had separated up to  $\frac{1}{4}$ " at the front. Much of the perimeter of the foundation was not observed due to obstructions. There are trees in the front yard that can continue to affect the performance of the foundation. Interior observations revealed a few drywall cracks. A few of the doors showed signs of misalignment. Inspection of the attic revealed the roof rafter/ridge framing joints were relatively tight. Measurements with the laser level revealed relatively minor floor slopes. The floor unlevelness was most evident at the front of the house. See drawing D-1.

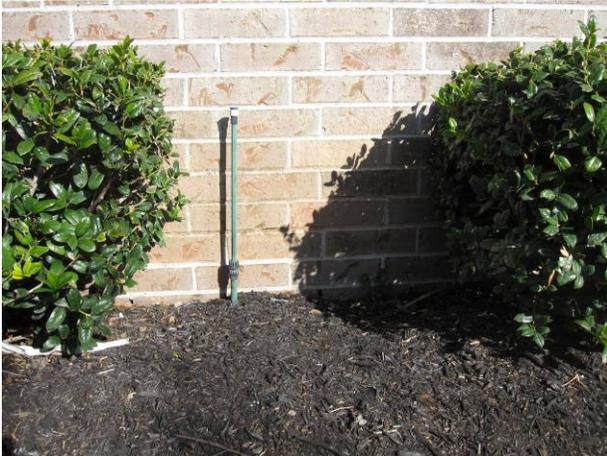
Some of the soil was above the lower brickline. This is a concern for water penetration and wood destroying insects. The grading should be 4" below the brickline and be sloped well away from the structure for drainage.
