On XX/XX/XXXX, Harris Engineering Real Estate Inspections, Inc. performed an inspection on the house at XXXX Road, Burton, Texas. The inspection was performed exclusively for Mr. Country Estate Buyer. We make no representation to the use of this report by any other party. No representation is made to any environmental aspects/hazards of this property.

The house was under construction at the time of the inspection. This is a one story residential structure with a post-tension cable reinforced concrete foundation. The foundation, framing, roof, exterior hardboard material, exterior wall sheathing, mechanical rough-in, electrical rough-in, and plumbing rough-in had been substantially completed. The purpose of this inspection was to determine whether these items had been completed in a workmanlike manner. We have performed no design analysis on any item. **No representation is made to future performance.** Please consult the builder's warranty.

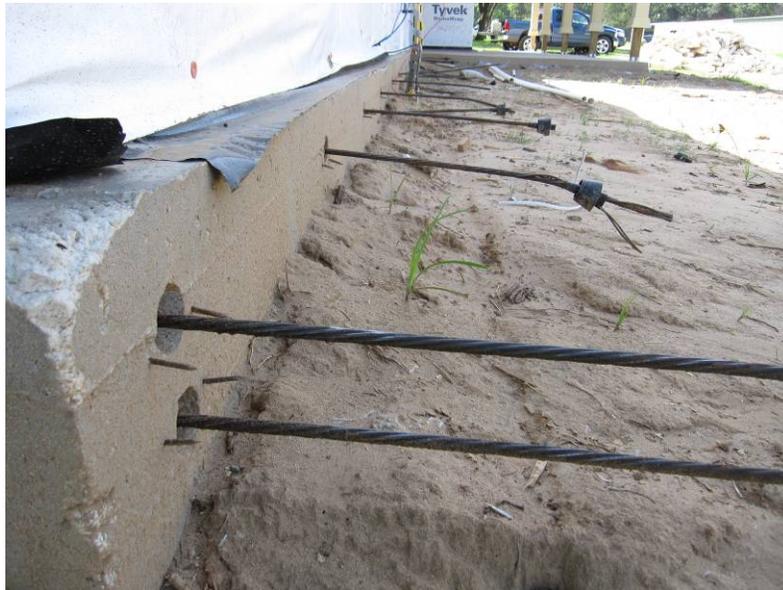
- It is recommended that you obtain engineer sealed foundation design documents and forward them to our office for review. It is our understanding that there has been some soil fill material placed below the foundation. It is recommended that you consult with the builder and foundation design engineer for soil pad construction specifications and compaction testing documents. Please forward these documents to our office for review.
- Post-tension cables had been stressed. However, these had not been cut and grouted.

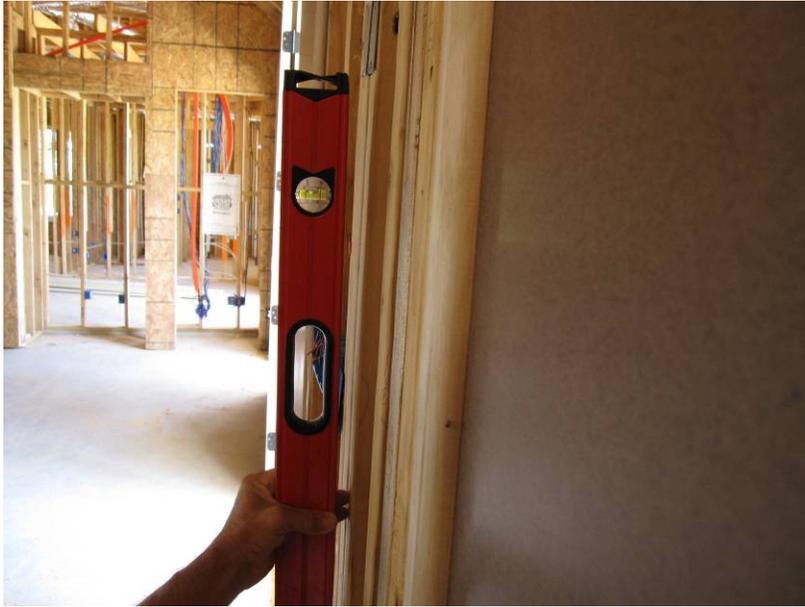
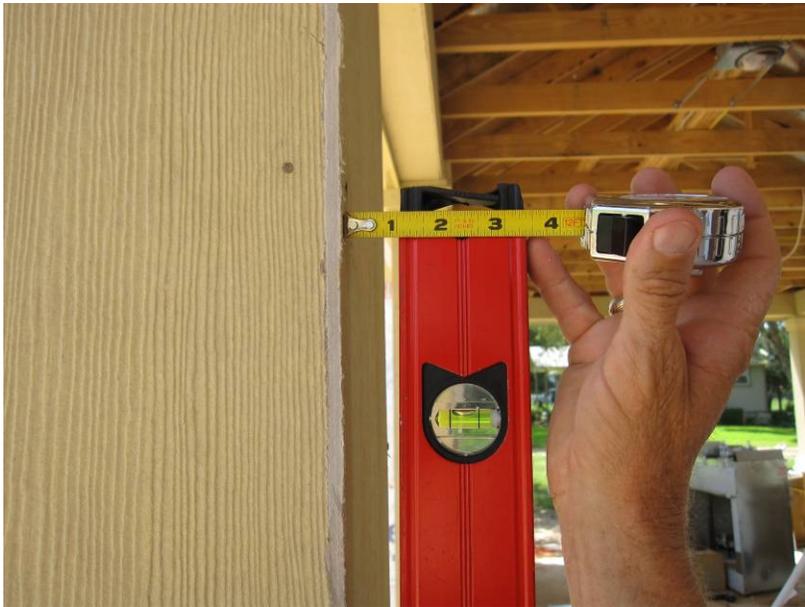
- Excessive framing distortion had occurred. The outside walls were unplumb, leaning toward the outside. The front wall of the living room was leaning out 2" in the 10' height. The rear wall of the living room was leaning out 1" in its 10' height. The front porch columns were leaning out. The front porch column unplumbness varied, with a maximum unplumbness of approximately 2½" in the 10' height. Rear porch columns were leaning out up to 1' in their 10' height. This excessive framing distortion was attributed to inadequate roof and ceiling framing, particularly at the family room area. There were a lack of rafter ties. It is our understanding that no engineering design had been performed. The builder was on-site at the time of the inspection. This condition was discussed with the builder. It is our understanding that the builder has consulted with a design engineer. The design engineer should perform a repair design and create detailed documents for proper repair of this condition. It is requested that you obtain engineering design documents and forward them to our office for review. It is recommended that you request the design engineer to perform on-site inspections during the repair process and that the design engineer verify that repairs have been properly performed. I had a brief telephone conversation with the design engineer. He stated that there would be rafter ties at 8' on-center. Rafter ties would generally be expected at 4' on-center. Please communicate this concern to the design engineer. Appropriate repairs should be made to bring the walls to a plumb condition. Industry standards are that walls shall be level, plumb, and square to all adjoining openings or other walls within 3/8" of an inch in 32" measurement.

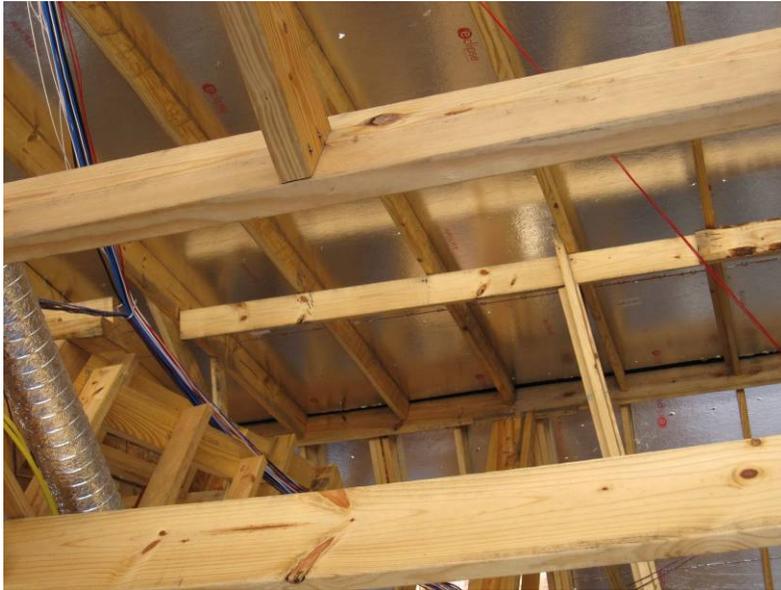
- The roof covering had not been installed. There were a lack of roof-top vents.
- A roof support strut had been removed near the family room fireplace. This is in need of being installed. Roof support struts shall be spaced at no more than 4' on-center.

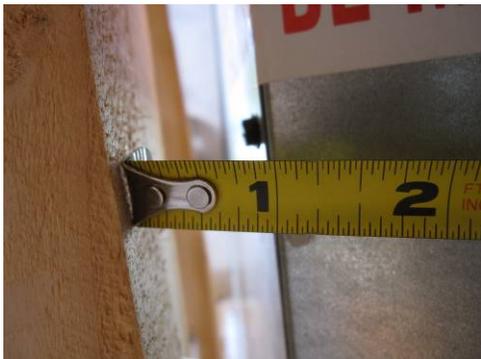
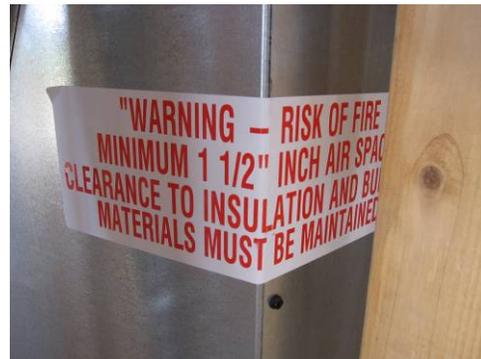
- Fireplaces and chimneys had not been completed. The family room fireplace had inadequate clearance to combustibles. A minimum 1½" clearance to combustibles is required. Top flashings had not been installed at both of the chimneys.

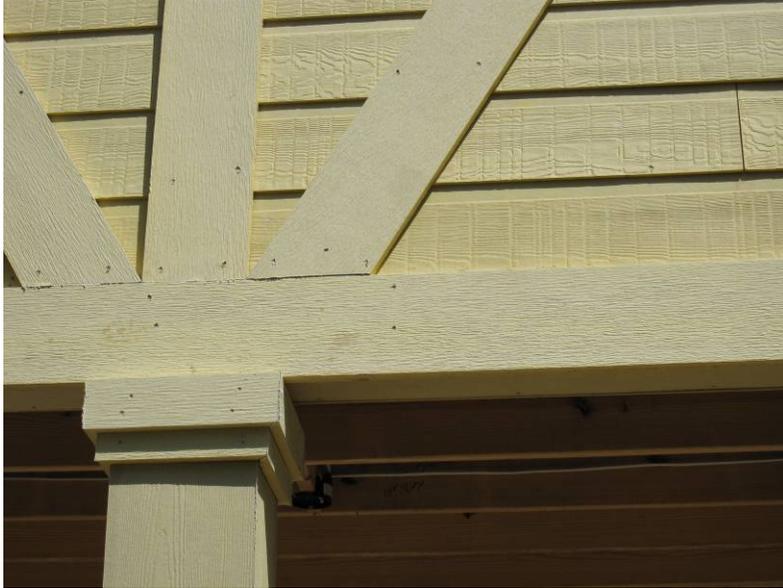
- There was a lack of Z-flashing at horizontal siding projection details at the left ends of the two left porches. Flashing is needed at horizontal siding projection details.

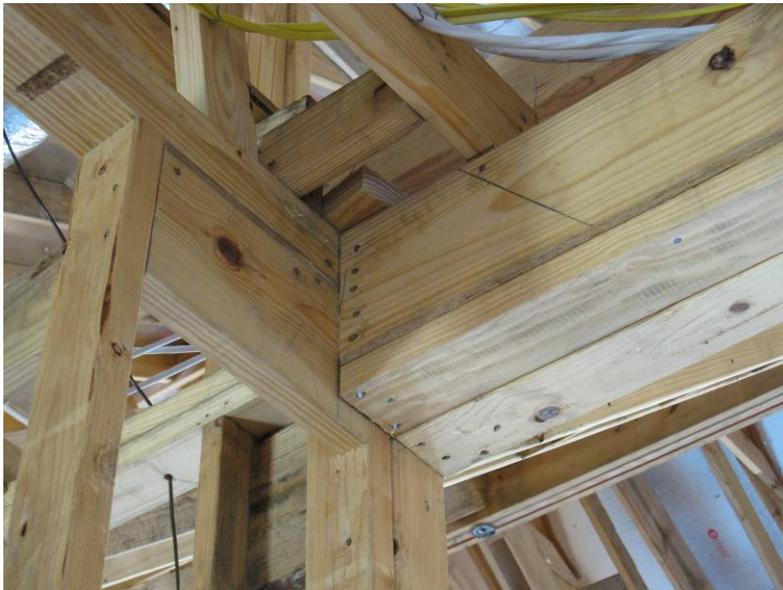
- There were a lack of joist hangers or a lack of stud support under both ends of a ceiling beam over the rear door alcove area. Proper support is needed for the ends of these beams.

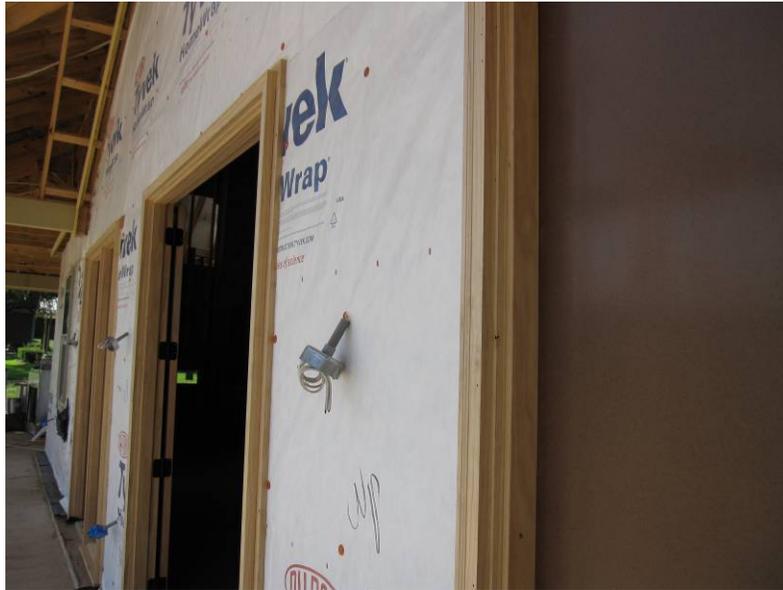
- There was inadequate access to mechanical equipment and water heater location in the attic. Proper walkways and work space are needed.
- The junction boxes for the outdoor wall lights were installed relatively low.

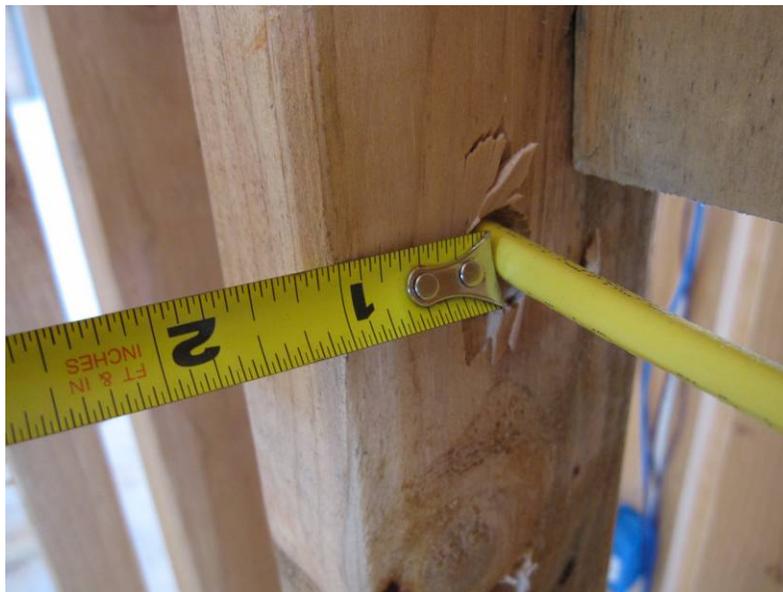
- There were various areas of missing nail protector plates.

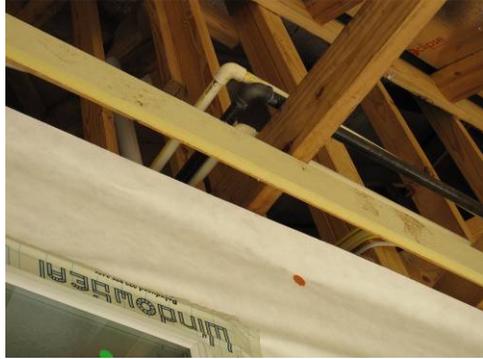
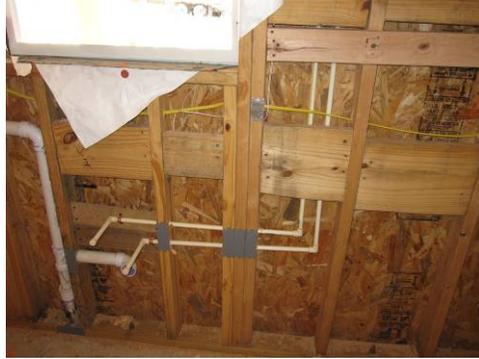
- There was a lack of insulation at water supply piping. All water supply piping is in need of being insulated, particularly over exterior porches and near exterior walls.

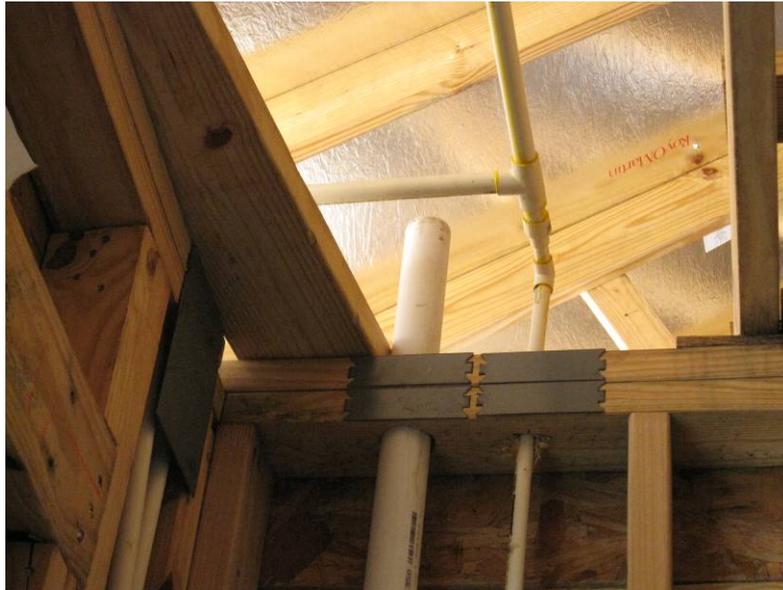
- The plumbing vents had not been connected in the attic. These had not been extended through the roof.

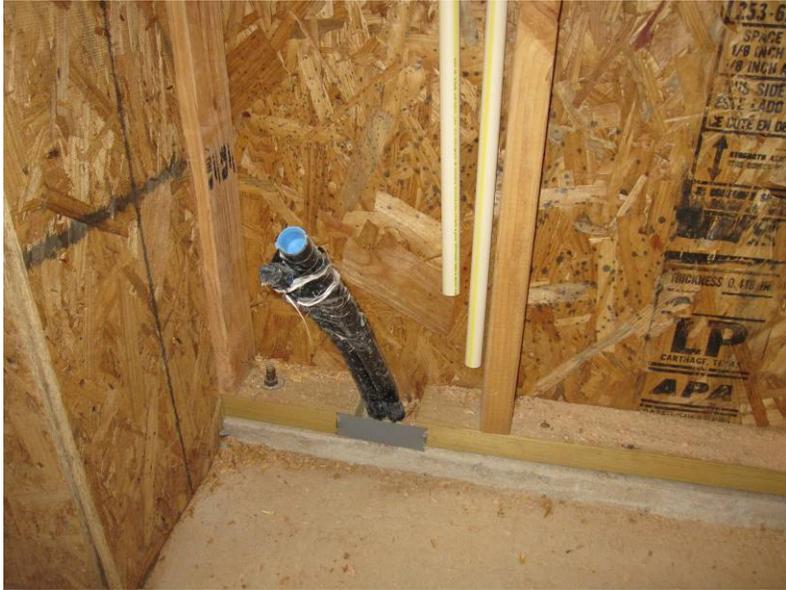
- The water supply had not been connected for the kitchen sink.
